Draft Final Report • National Institute of Standards and Technology (NIST)

of the May 22, 2011,
Tornado in
Joplin, Missouri

NIST NCSTAR 3 (Draft)

November 2013

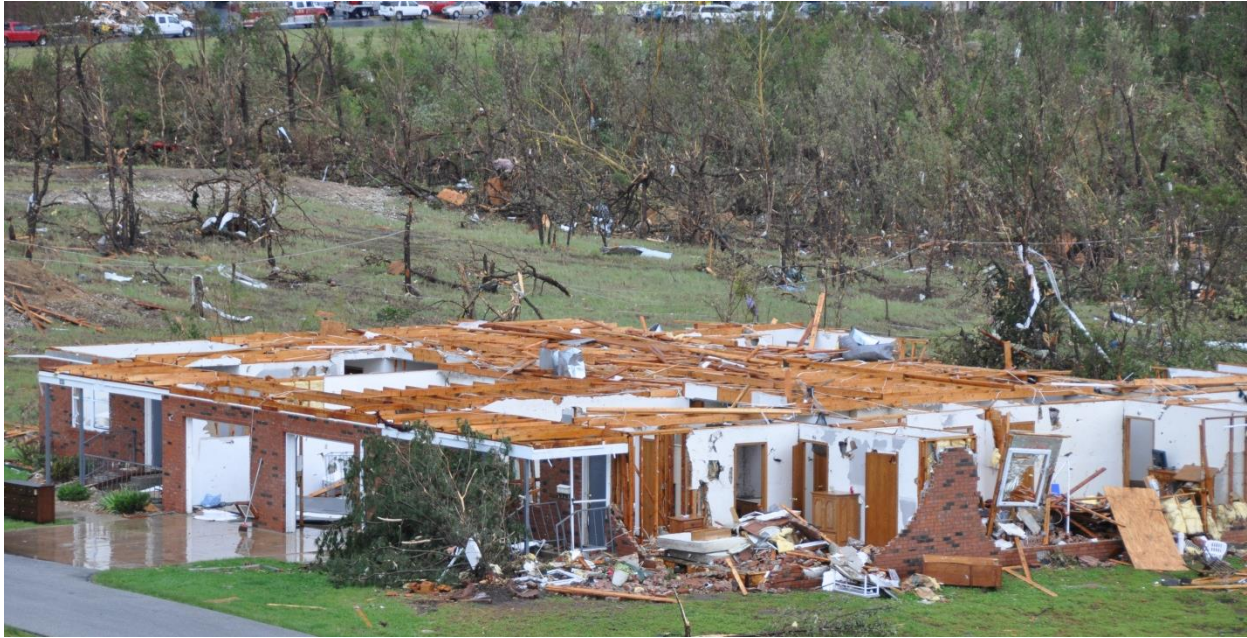
Figure 3-115. Disconnection and loss of entire roof system.

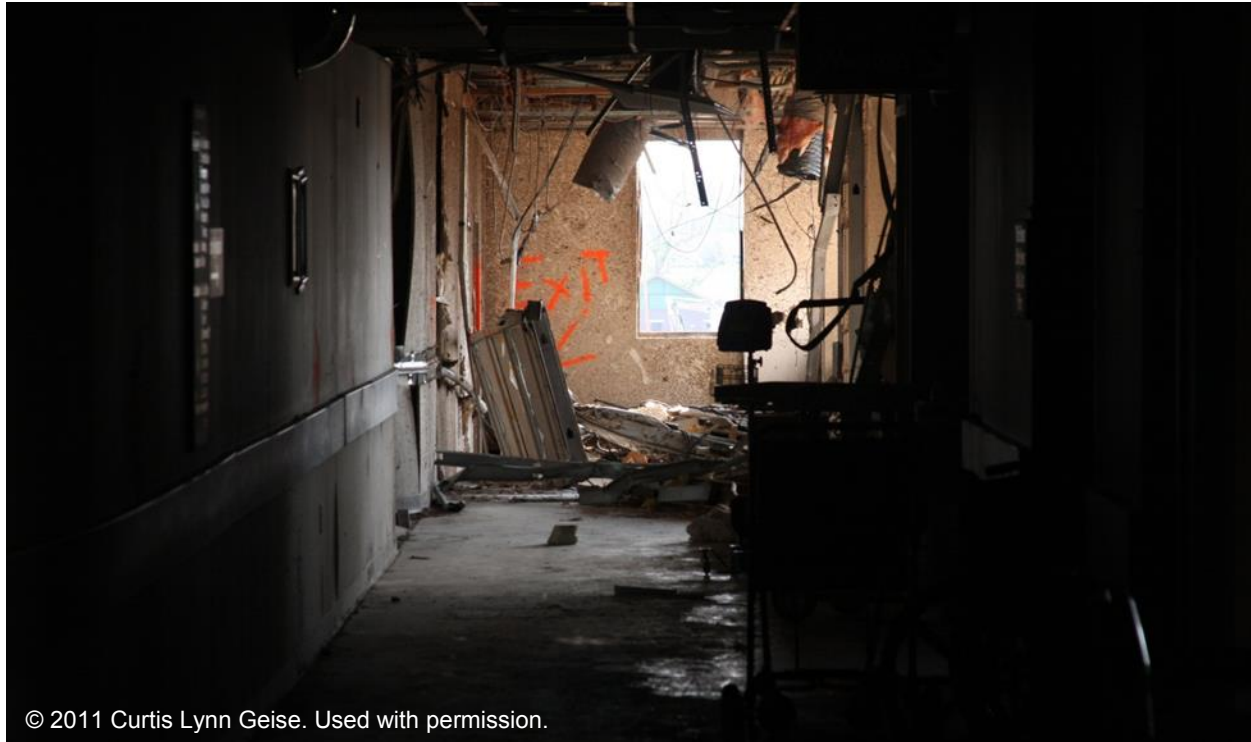
Figure 3–126. View of a typical hallway with damaged interior (ceiling, walls, and debris); hallways were used as designated refuge areas in SJRMC’s East and West Towers.

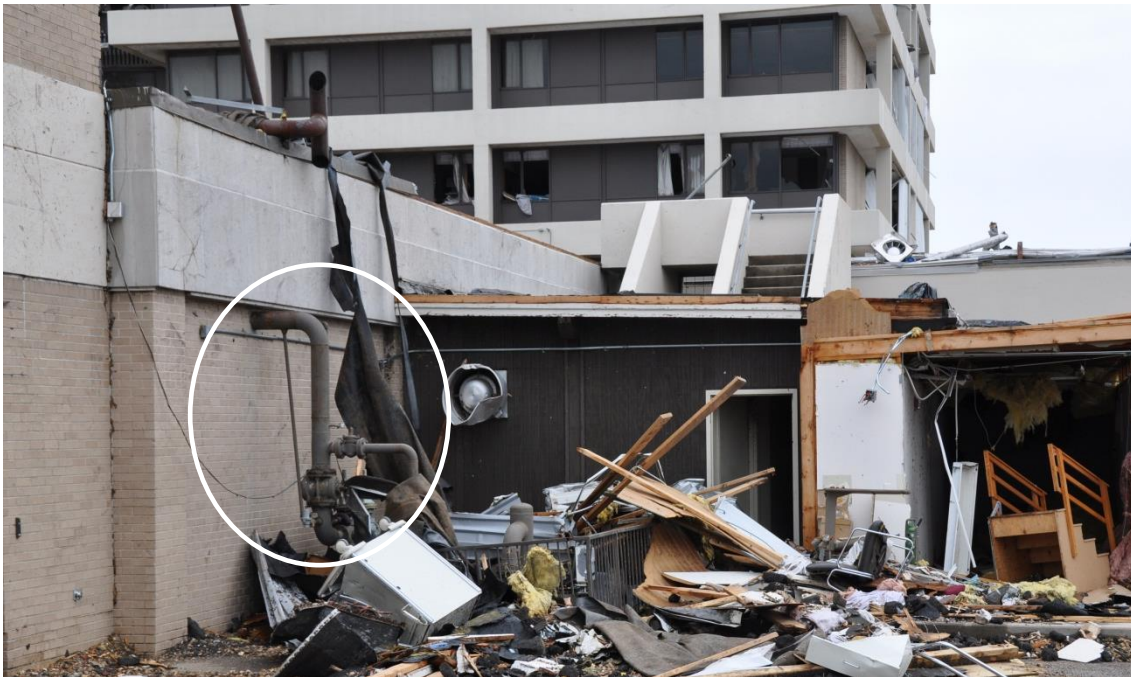
Figure 3–132. High–pressure gas reducer valve at SJRMC that was damaged and leaked.
